WDA No 005 T1 MPVP

Objective. Turbine 1 Oil Sample from 1/07/2015. Complete Laboratory analysis on sample, information found used to establish machine condition and future maintenance requirements.

Turbine 1

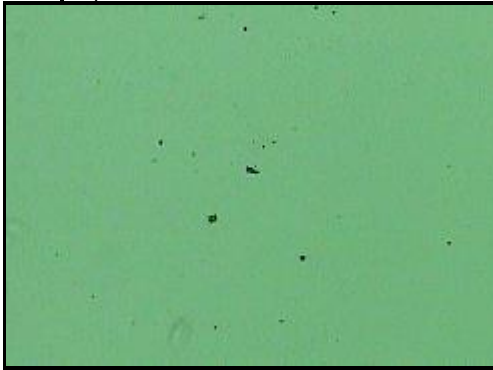
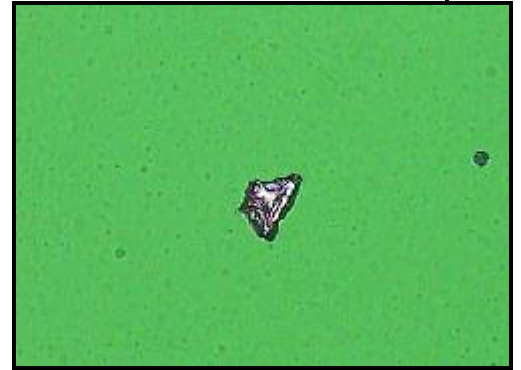
3 µm Membrane Filter

These images at 100X/500X indicates the average wear debris and contamination deposited on the analysis filter from 1 CC of the sample being forced through the 3-µm Membrane Analysis Filter.

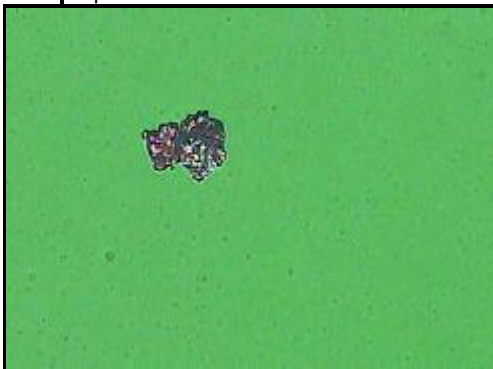
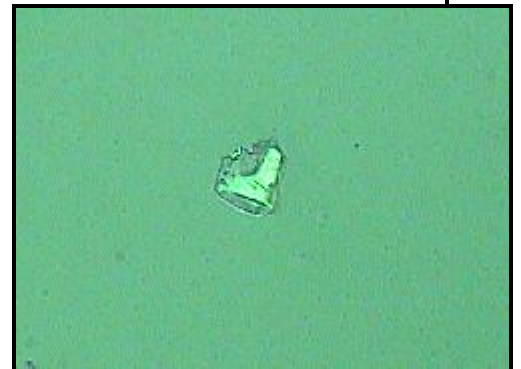
3 µm Membrane Filter

**Fine Metallic Wear Particle & Silica Type Crystal
@ 500X Sized 0.5-50 µm**

There was a few of these fine contaminates found in the sample.

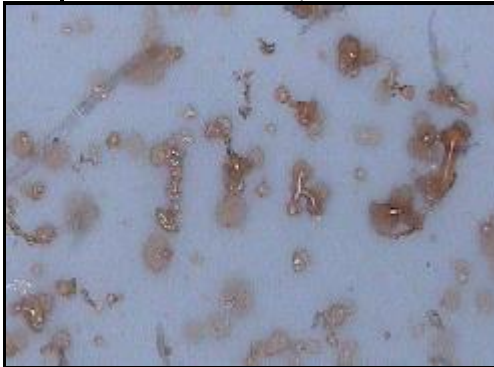
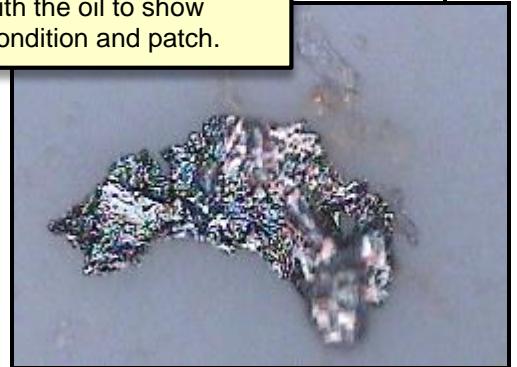
Turbine 1 MPV @ 0.45 µm Processed @ Ambient Temperature

Synthetic Fibres

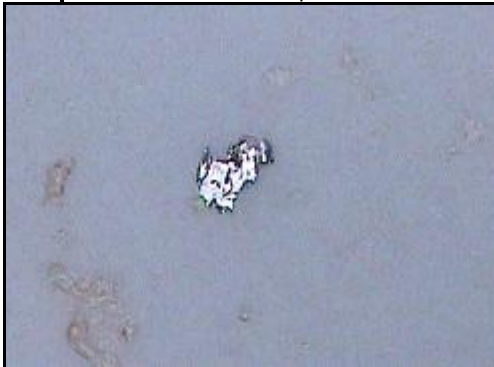
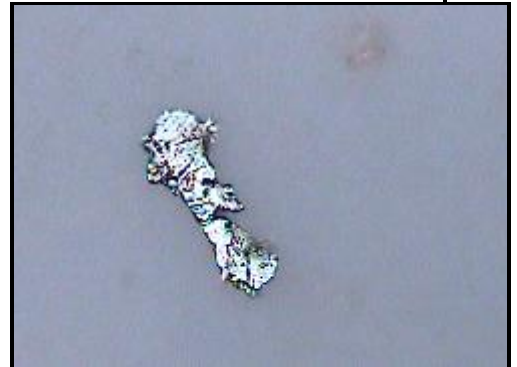
Turbine 1 MPV @ 0.45 µm Processed @ Ambient Temperature

Hard Particle Damaged Metallic Wear Debris.
@ 500X Sized 0.2-55 µm
Brightfield

This sample has a few to light amount of fine metallic wear debris present.

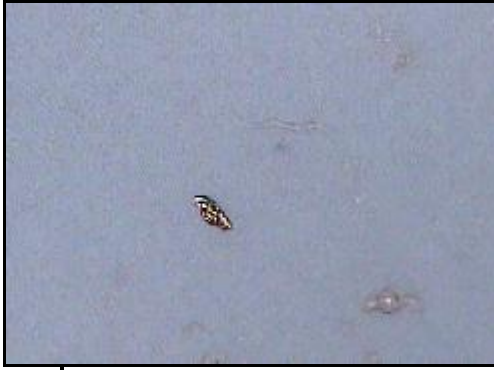
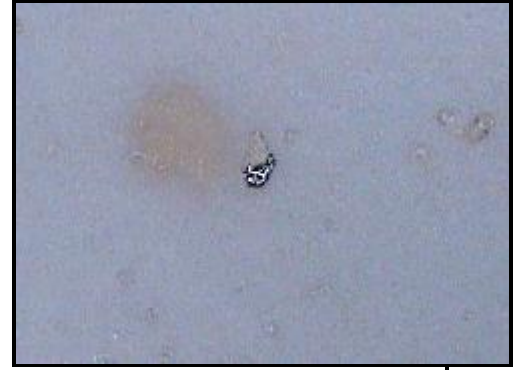
Turbine 1 MPV @ 0.45 μm Processed @ Ambient Temperature

**Hard Particle Damaged
Metallic Wear Debris.
@ 500X Sized 0.2-10 μm**
Brightfield

This sample has a few to light amount of fine metallic wear debris present.

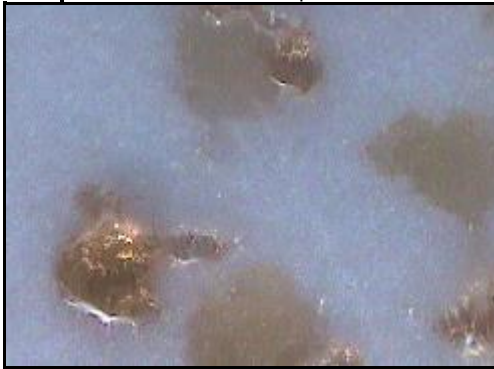
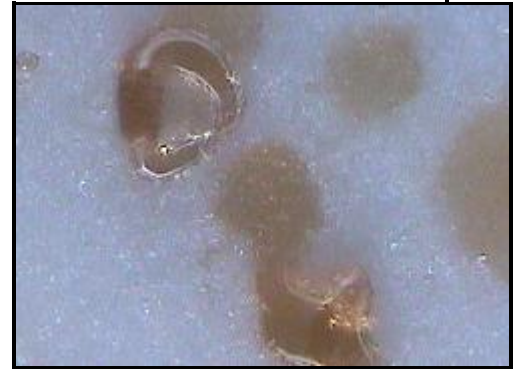
Turbine 1 MPV @ 0.45 μm Processed @ Ambient Temperature

**Gelled Lubricant
@ 500X Sized 0.2-75 μm**
Darkfield

These shaped deposits of gelled lubricant are a result of the increase in solubility of the lubricant reabsorbing gelled lubricant deposits from throughout the system.

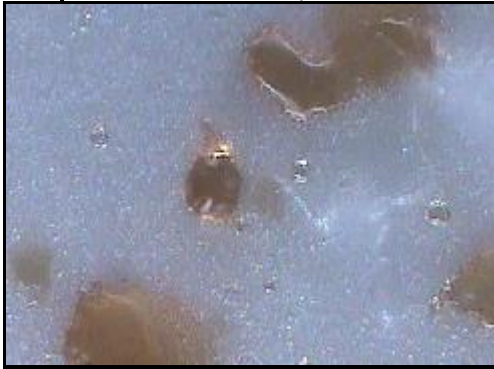
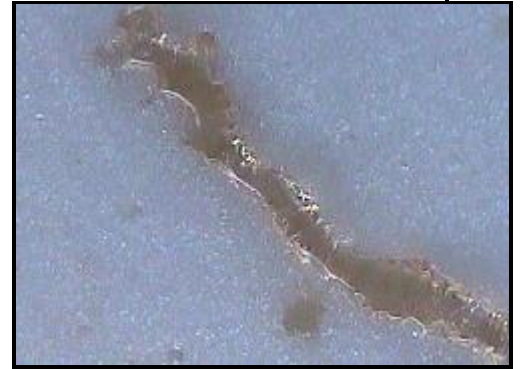
Turbine 1 MPV @ 0.45 μm Processed @ Ambient Temperature

**Gelled Lubricant
@ 500X Sized 0.2-75 μm**
Darkfield

These shaped deposits of gelled lubricant are a result of the increase in solubility of the lubricant reabsorbing gelled lubricant deposits from throughout the system.

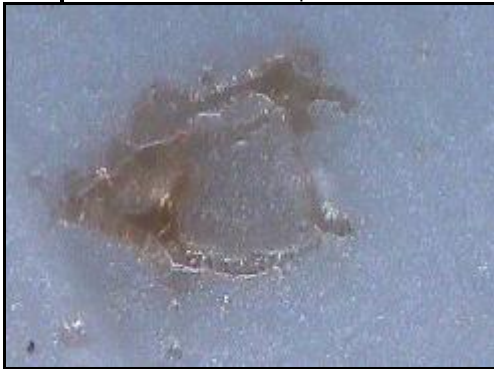
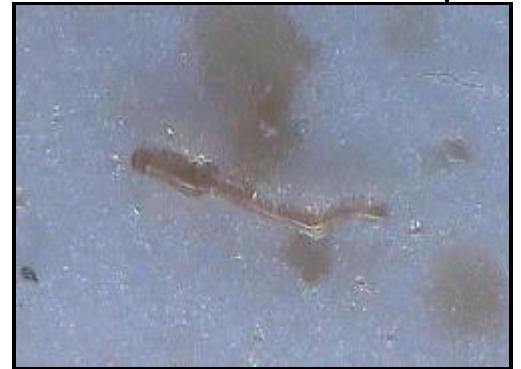
Turbine 1 MPV @ 0.45 μm Processed @ Ambient Temperature

**Gelled Lubricant
@ 500X Sized 0.2-15 μm**
Darkfield

These shaped deposits of gelled lubricant are a result of the increase in solubility of the lubricant reabsorbing gelled lubricant deposits from throughout the system.
