<u>WDA No 000 Dust Sample</u>	Factory Dust Sample
Client Company Company Details Attention of Client Name Contact Details	
Objective. Factory Dust Sample taken 1/07/2015. Complete Laboratory analysis on sample, information found used to establish machine condition and future maintenance requirements.	
Method. Sample preparation in accordance with R&T's Procedure No. 30. Tape Sample. A sample of approximately 20 sq cm was uplifted, Images processed directly from tape sample, therefore the amount seen in the video pictures is the debris concentration per sq cm removed off the machine surface

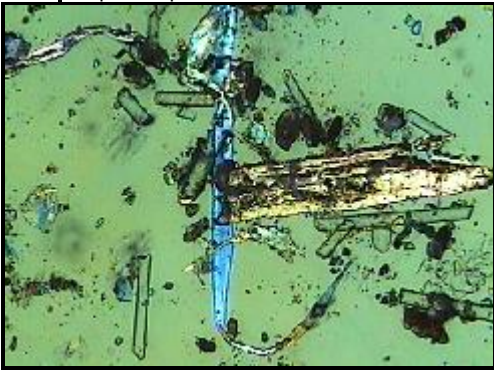
Tape sample	Uplifted from machine surface

<p>This image at 100X indicates the average wear debris and contamination deposited on the analysis filter from 1 CC of the sample being forced through the 3-µm Membrane Analysis Filter.</p> <p>The brightness of microscope's bottom Green/Blue light shining up through the sample provides an indication of the level of wear debris and contamination per CC of sample.</p> <p style="text-align: center;">└───┘ 100 µm</p>

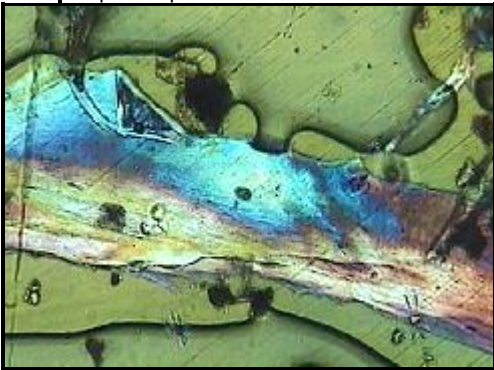
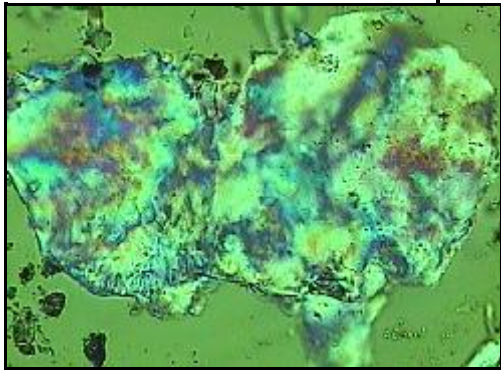
Tape sample	Uplifted from machine surface

<p style="text-align: center;">Organic Debris & Fibres @ 200X Sized 0.5-230 µm</p> <p>There was a light amount of these light airborne organic fibres in the sample.</p> <p style="text-align: center;">└───┘ 50 µm</p>

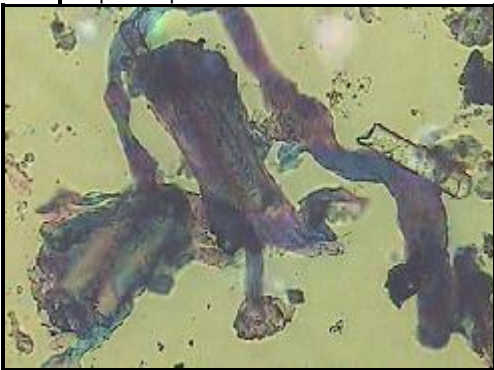
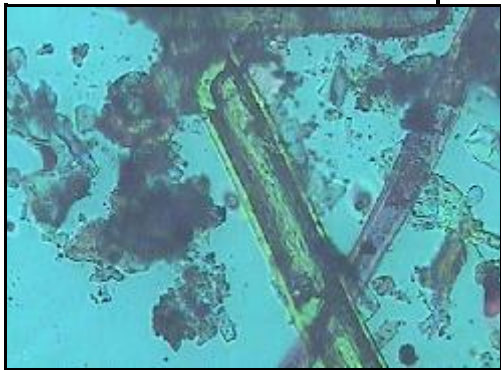
Tape sample	Uplifted from machine surface

<p style="text-align: center;">Organic Debris & Fibres @ 200X Sized 0.5-300 µm</p> <p>There was a light amount of these light airborne organic fibres in the sample.</p> <p style="text-align: center;">└───┘ 50 µm</p>

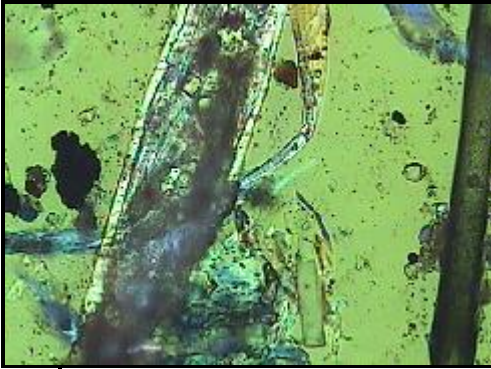
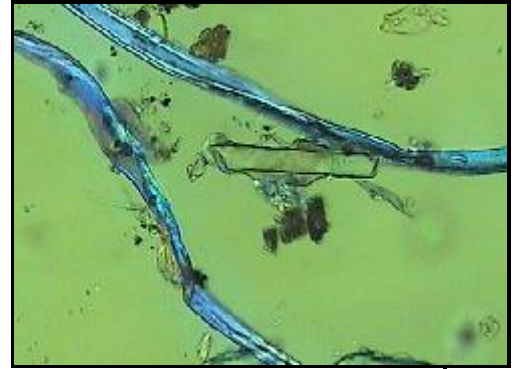
Tape sample

**Organic Fibres & Synthetic Fibres
@ 200X Sized 0.5-150 µm**

There was a light amount of these light airborne organic fibres in the sample.

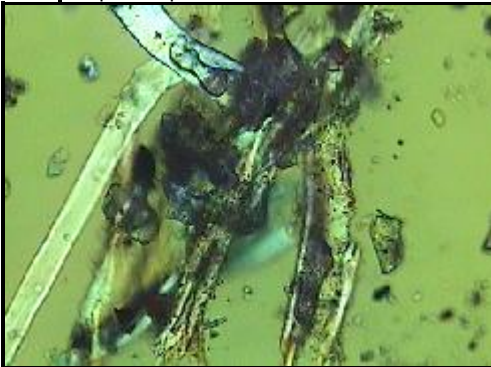
Tape sample

**Organic Fibres & Glass Fibres
@ 200X Sized 0.5-150 µm**

There was a moderate amount of these glass fibres deposited upon machine surface.

The Factory Dust Sample Oil Sample indicates factory dust include organic debris, glass reinforcement fibres from the plastic, a few polymer particles and a light to moderate amount of fine hard silica type crystals found on the tape sample. The majority of this dirt and debris will either damage the lubricant and or damage the hydraulic pump indicating hydraulic reservoir breathers will be best upgraded to prevent any environmental contamination entry.

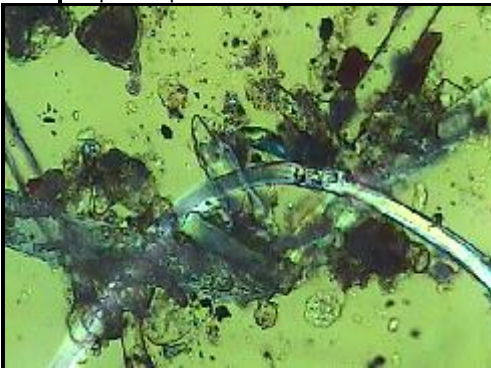
Tape sample

**Organic Fibres & Glass Fibres
@ 200X Sized 0.5-150 µm**

There was a moderate amount of these glass fibres deposited upon machine surface.

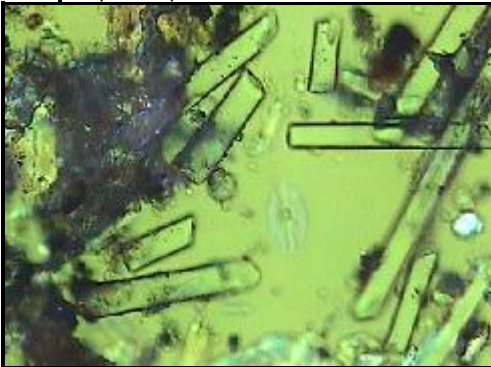
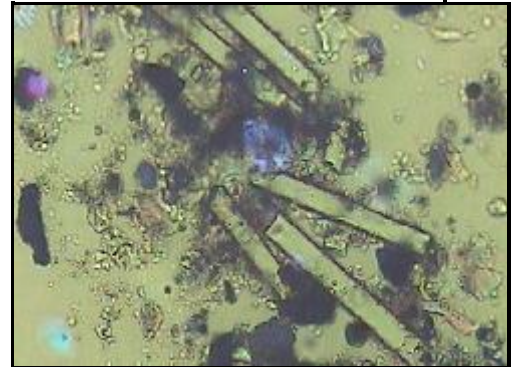
Tape sample

**Organic Fibres & Glass Fibres
@ 200X Sized 0.5-150 µm**

There was a moderate amount of these glass fibres deposited upon machine surface.

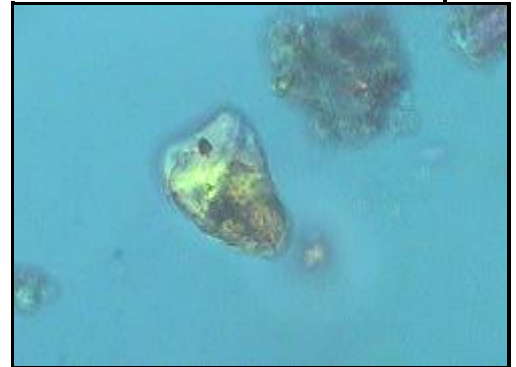
Tape sample

**Fine Hard Silica Type Crystals
@ 200X Sized 0.5-30 µm**

There was a light to moderate amount of fine hard environmental contaminates present in the sample.

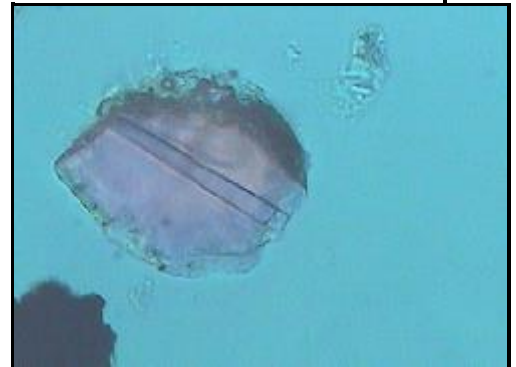
Tape sample

**Fine Hard Silica Type Crystals
@ 200X Sized 0.5-50 µm**

There was a light to moderate amount of fine hard environmental contaminates present in the sample.
