WDA No 002 SC1

<p style="text-align: center; color: yellow;">Screw Compressor 1</p>
Client Company Company Details Attention of Client Name Contact Details	
Objective. Screw Compressor 1 Oil Sample from 1/07/2015. Complete Laboratory analysis on sample, information found used to establish machine condition and future maintenance requirements.	
Method. Sample approx 100 mL received, Sample preparation in accordance with Procedure No. 22. One sample processed 1 mL in volume, therefore the amount seen in the video pictures is relatable to the debris concentration per mL of oil.

ISO 4407 Cleanness Code for Wear Debris Analysis No 002 SC1 - ISO 17/14

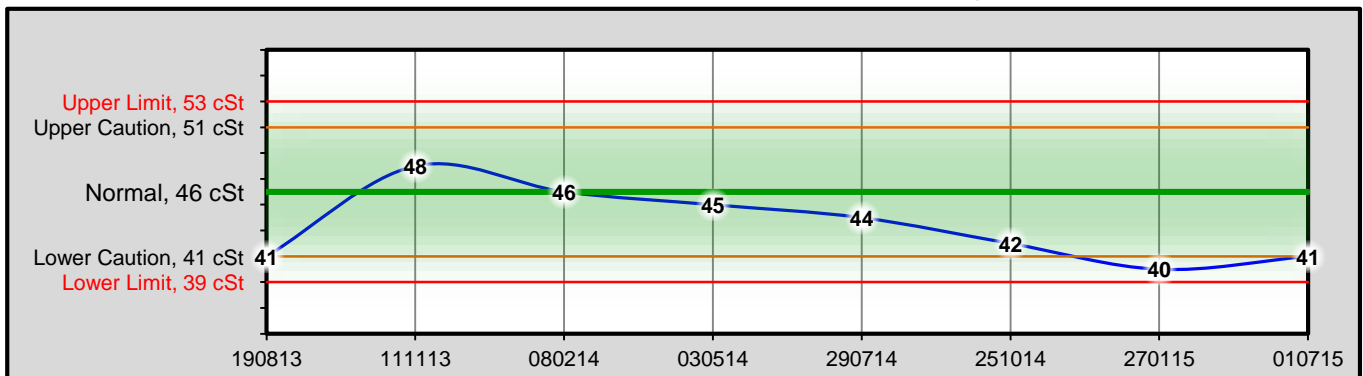
Atlas Copco GR10 SW150 Compressor Fluid Upper & Lower limits, Sample Viscosity cSt @ 40 °C

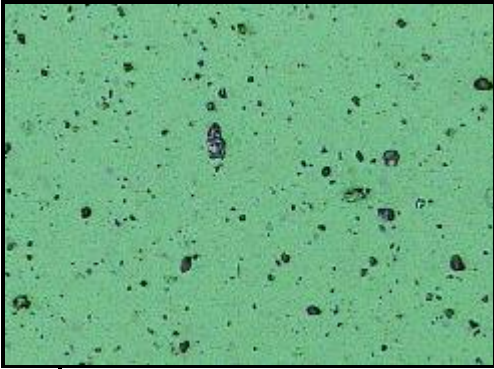
3 µm Membrane Filter

This image at 100X indicates the average wear debris and contamination deposited on the analysis filter from 1 CC of the sample being forced through the 3-µm Membrane Analysis Filter.

The brightness of microscope's bottom Green/Blue light shining up through the sample provides an indication of the level of wear debris and contamination per CC of sample.

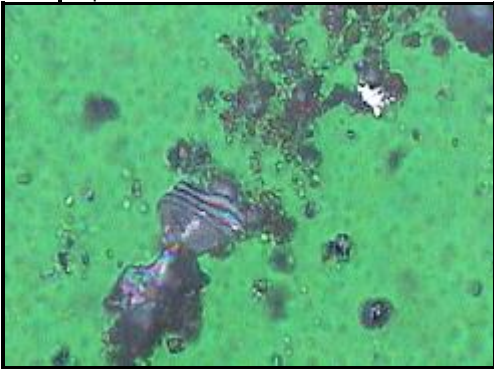
3 µm Membrane Filter

**Fine Hard Particle Damaged
Metallic Wear Debris
@ 500X Sized 0.5-150 µm**

There was a light amount of this fine hard particle catalysed metallic wear debris present.

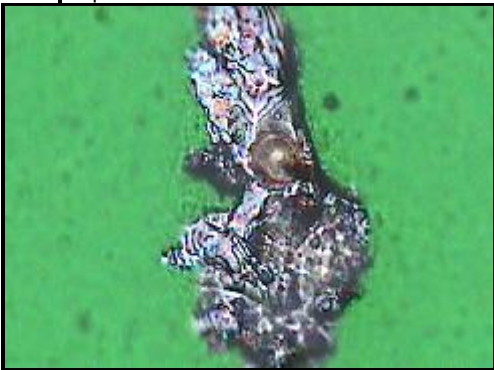
3 µm Membrane Filter

**Fine Hard Particle Damaged
Metallic Wear Debris
@ 500X Sized 0.5-150 µm**

There was a light amount of this fine hard particle catalysed metallic wear debris present.

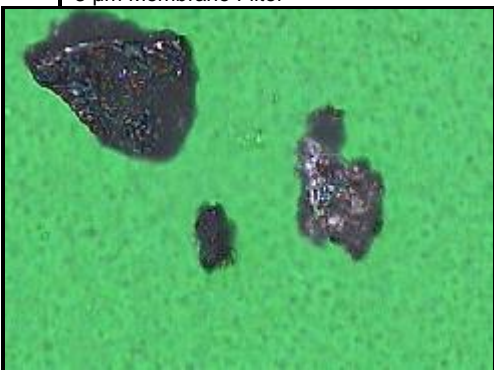
3 µm Membrane Filter

**Fine Hard Particle Damaged
Metallic Wear Debris
@ 500X Sized 0.5-150 µm**

There was a moderate amount of this fine hard particle catalysed metallic wear debris present.

The SC1 Screw Compressor 1 Oil Sample indicates the compressor has continued being lightly dusted with a light amount of fine silica crystals deposited upon the analysis filter.
