**WDA No 005 T1 MPVP**

**Objective.** Turbine 1 Oil Sample from 1/07/2015. Complete Laboratory analysis on sample, information found used to establish machine condition and future maintenance requirements.

**# 005 Turbine 1 MPV @ 0.45 µm Processed @ Ambient Temperature**

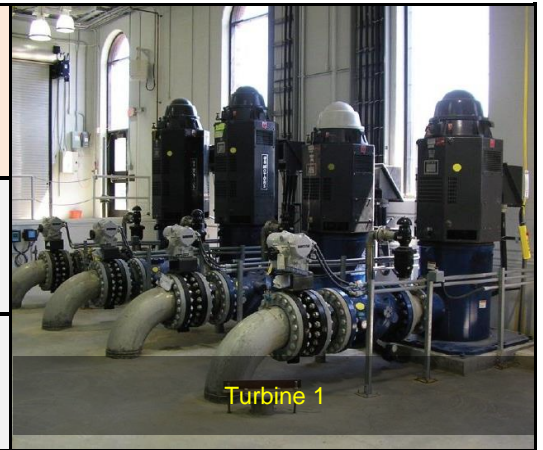
**ISO 4406 Cleanness Code for Wear Debris Analysis No 005 T1 MPVP - ISO 17/15/11**

The Turbine 1 Oil Sample indicates the system is wearing in a normal wear mode at a low rate of wear with a few fine metallic particles deposited upon the analysis filter.

Resample in 800 operating hours to check the machine trends.

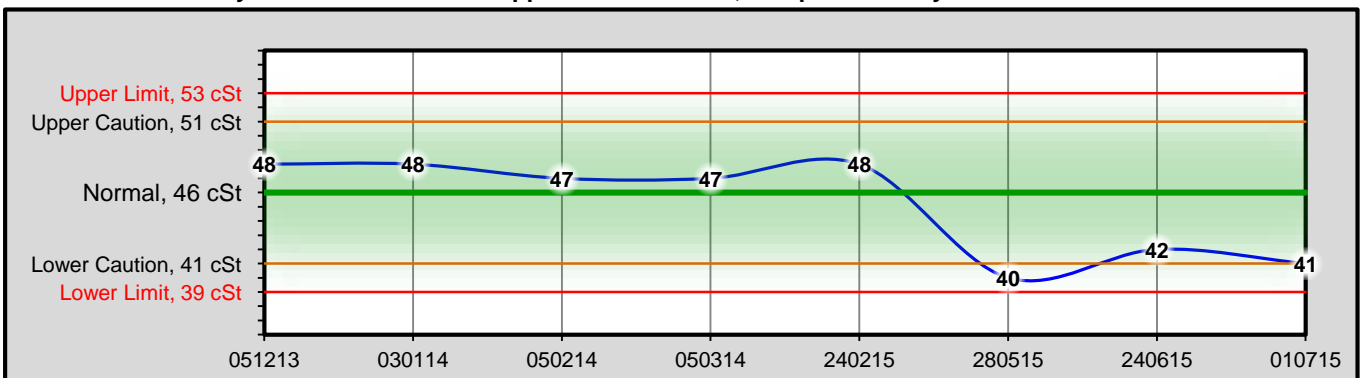
**Conoco Ecoterra Hydraulic Fluid ISO 46 - Upper & Lower limits, Sample Viscosity cSt @ 40 °C**

The viscosity remains lower with the removal of the heavier ends of damaged lubricant and if this trend continues the system could have a small volume refresh with an ISO 68 Fluid to restore specification back to an ISO 46 but at present viscosity remains in the normal range. Resample in 800 hour to monitor the systems trends.

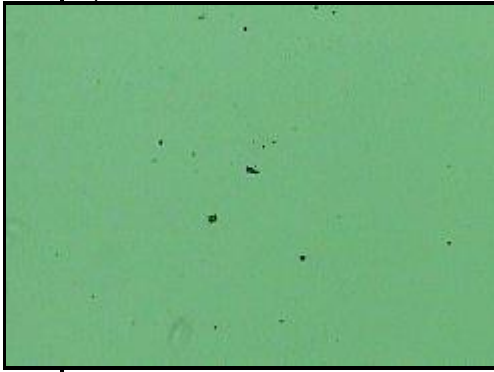
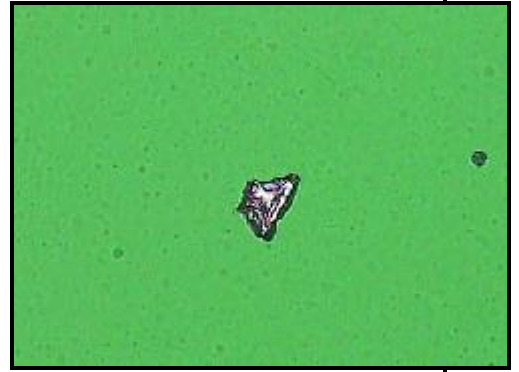
3 µm Membrane Filter

These images at 100X/500X indicates the average wear debris and contamination deposited on the analysis filter from 1 CC of the sample being forced through the 3-µm Membrane Analysis Filter.

The brightness of microscope's bottom Green/Blue light shining up through the sample provides an indication of the level of wear debris and contamination per CC of sample.

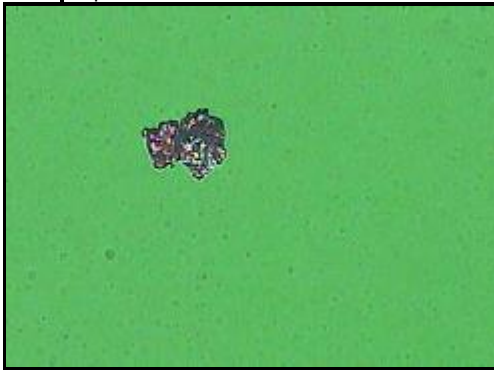
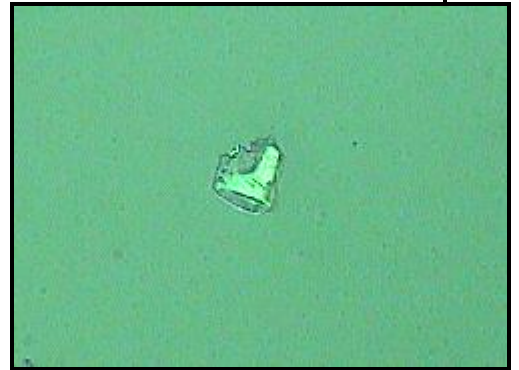
3 µm Membrane Filter

**Fine Metallic Wear Particle & Silica Type Crystal @ 500X Sized 0.5-50 µm**

There was a few of these fine contaminates found in the sample.

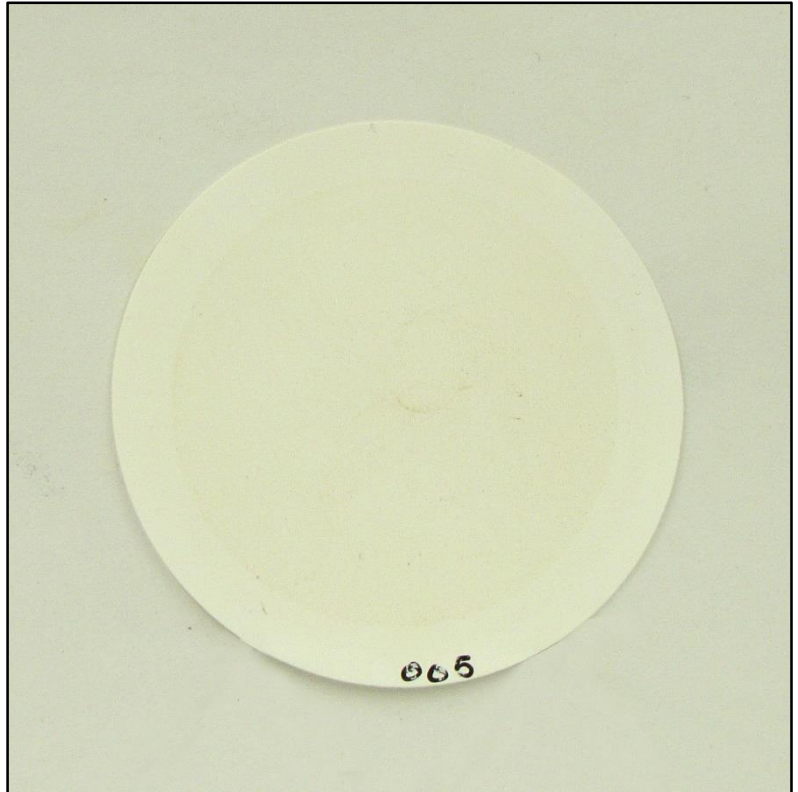
The MPVP (Membrane Patch Varnish Potential) part of this analysis checks for damage to the fluid being analysed, this analysis uses a 50X larger volume of sample and filters down to a 1/6th of the size of the filter used for the WDA analysis.

The Membrane Patch Filter was gravimetrically analysed with the layer of varnish damaged lubricant imaged and weighed. Next the patch was inspected and analysed under the microscope to ascertain the depth and types of contaminates deposited upon the Membrane Patch Varnish Potential Filter.

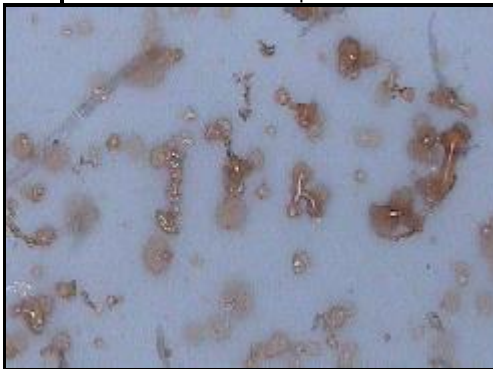
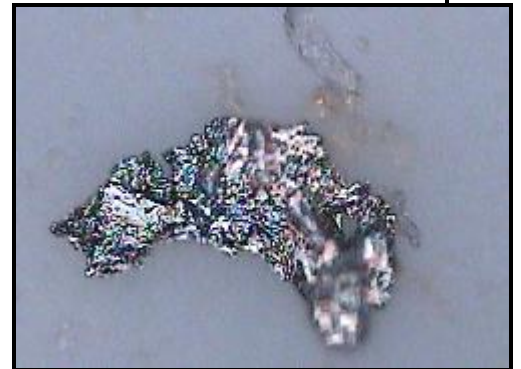
Turbine 1 MPV @ 0.45 µm Processed @ Ambient Temperature

100X Brightfield

500X Darkfield

Synthetic Fibres

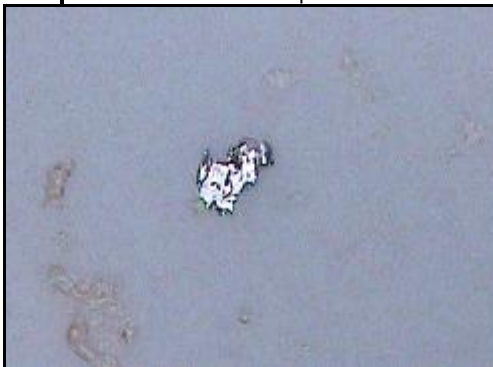
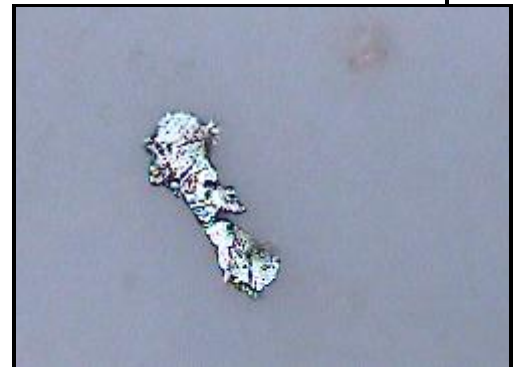
Turbine 1 MPV @ 0.45 µm Processed @ Ambient Temperature

Hard Particle Damaged  
Metallic Wear Debris.  
@ 500X Sized 0.2-55 µm  
Brightfield

This sample has a few to light amount of fine metallic wear debris present.

The Turbine 1 Oil Sample Membrane Patch Filter analysis indicates the system has continued to clean the degraded lubricant from out of the system with these large globules of resolubilised gelled lubricant removed from the sample. The rate of wear is low with only a few fine metallic particle found in the analysis filters.

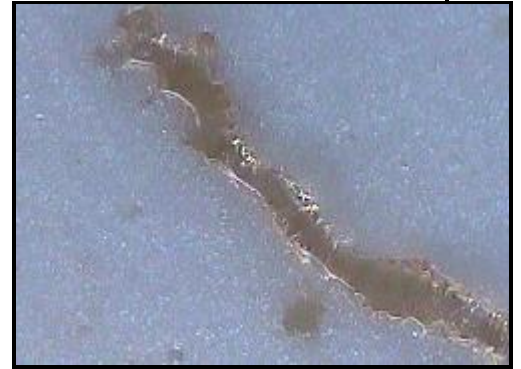
Turbine 1 MPV @ 0.45  $\mu\text{m}$  Processed @ Ambient Temperature

**Gelled Lubricant  
@ 500X Sized 0.2-75  $\mu\text{m}$**   
Darkfield

These shaped deposits of gelled lubricant are a result of the increase in solubility of the lubricant reabsorbing gelled lubricant deposits from throughout the system.

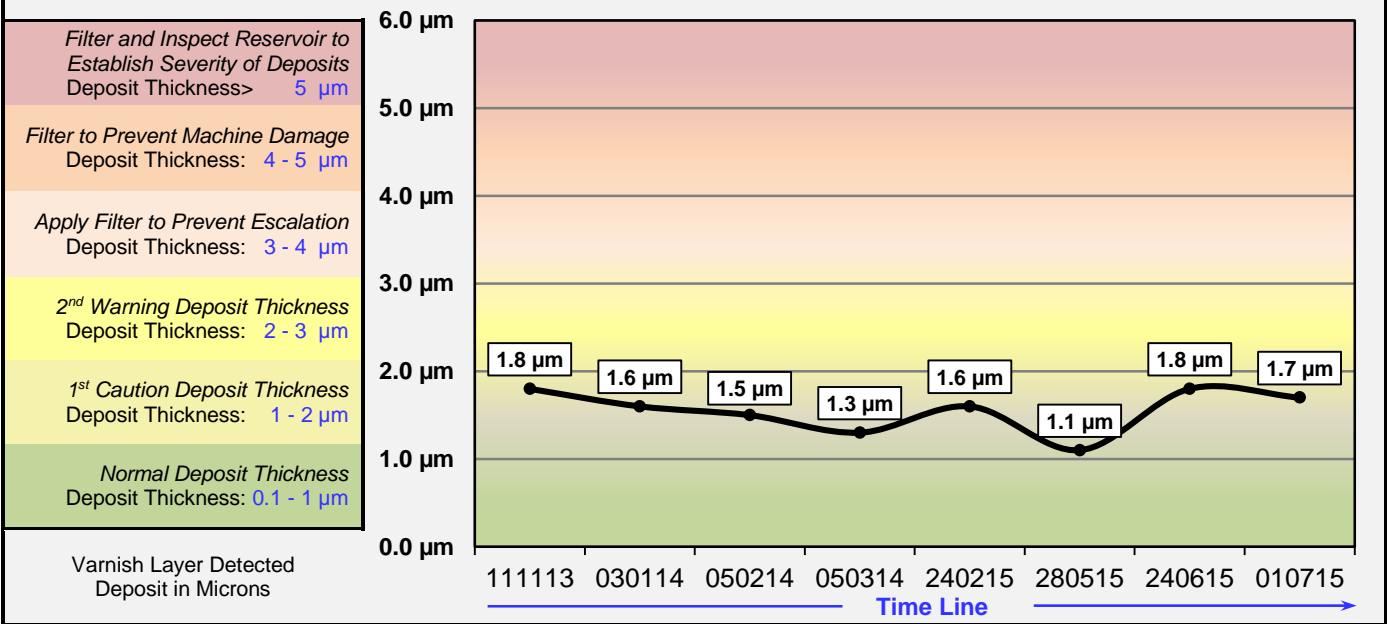
**Sludge and Soft Varnish Layer Deposited upon the 0.45 µm Membrane Patch Filter**

Thickness of deposit in micrometres

The Turbine 1 Oil Sample Membrane Patch Filter analysis indicates the system is slowly cleaning it's self with the smooth layer of damaged lubricant deposited reducing back to 1.1  $\mu\text{m}$  of layered gelled lubricant.

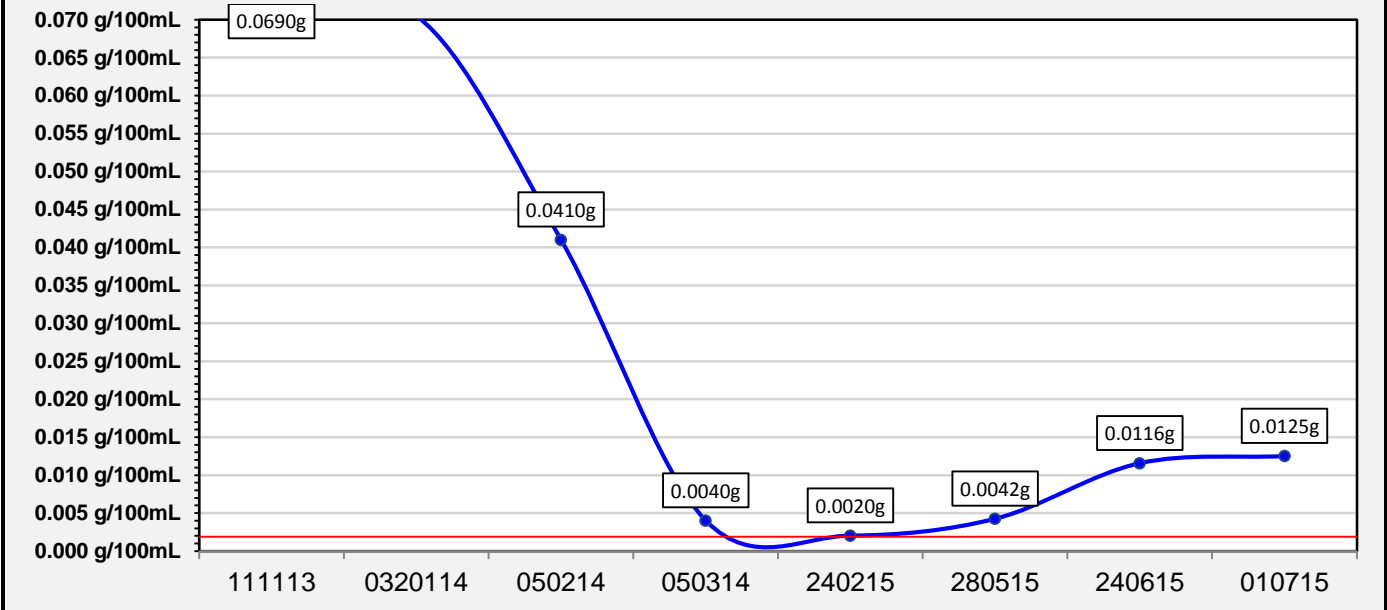
**Gravimetric Analysis Measuring Insolubles Deposited upon the 0.45 µm Membrane Patch Filter**

Weight of deposit in grams per 100 millilitres

A typical warning limit for insolubles in turbine fluid is 0.002g/100mL

The resolubilised globules of gelled lubricant deposited increased the gravimetric analysis insoluble weight with 0.01250 g of insoluble debris per 100 mL of turbine fluid sample deposited upon the Membrane Patch Filter.
