WDA No 005 T1 MPVP

Objective. Turbine 1 Oil Sample from 1/07/2015. Complete Laboratory analysis on sample, information found used to establish machine condition and future maintenance requirements.

Turbine 1

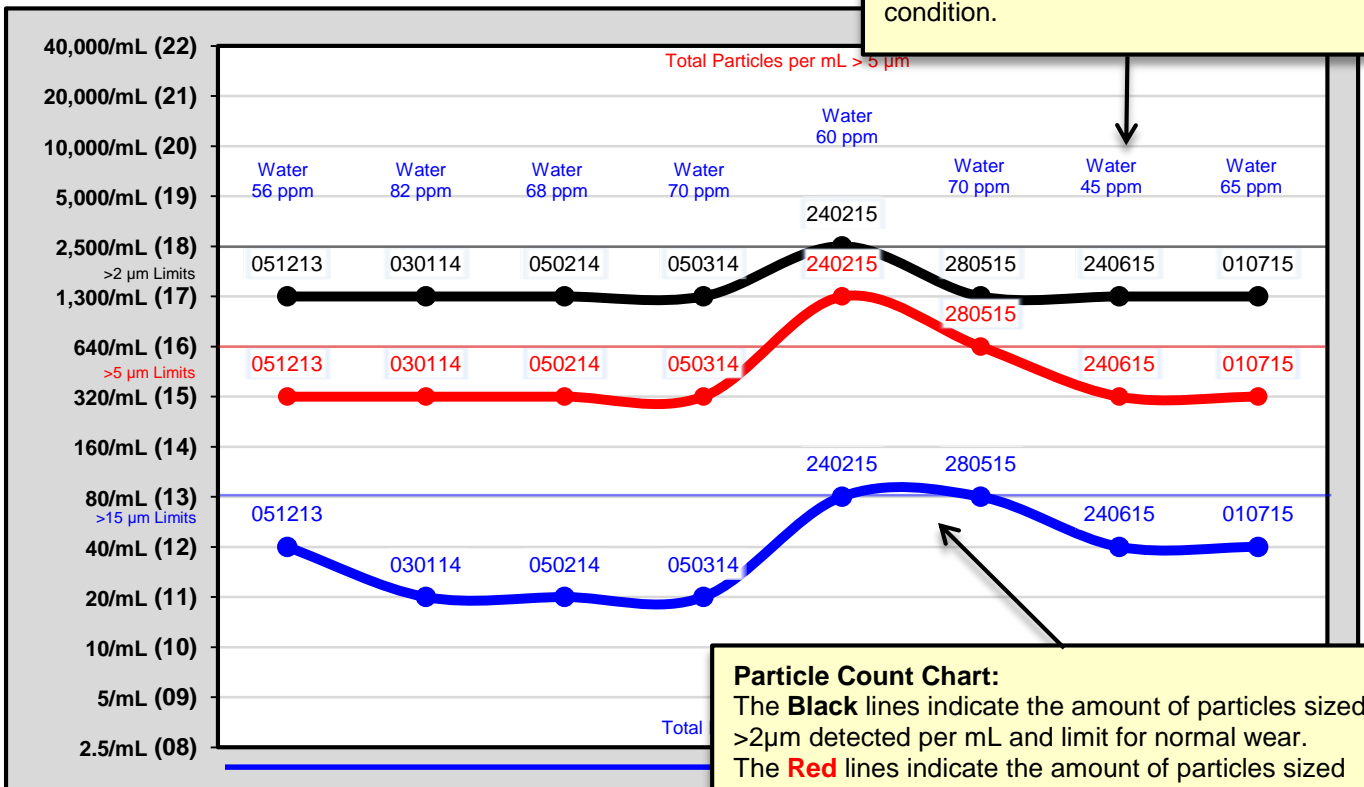
Particle Count Chart:
 The **Black** lines indicate the amount of particles sized >2µm detected per mL and limit for normal wear.
 The **Red** lines indicate the amount of particles sized >5µm detected per mL and limit for normal wear.
 The **Blue** lines indicate the amount of particles sized >15 µm detected per mL and limit for normal wear.

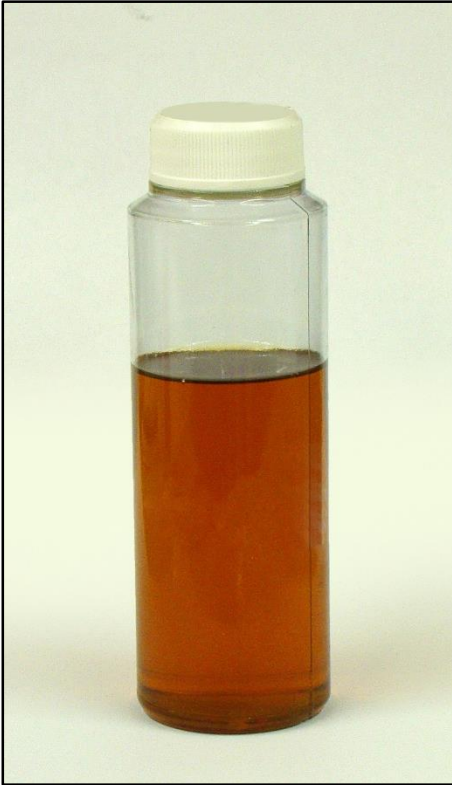
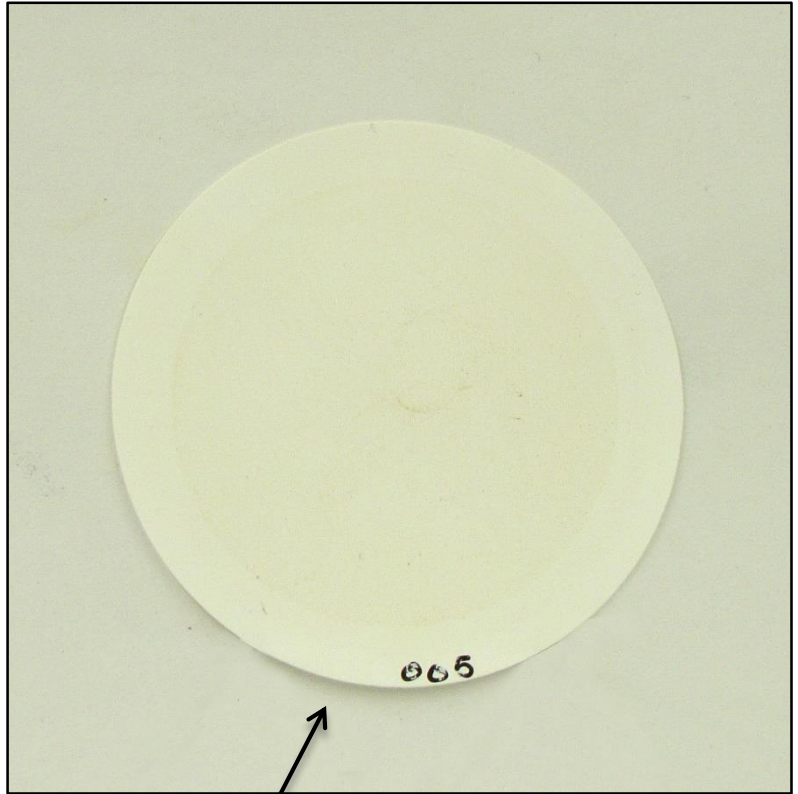
005 Turbine 1 MPV @ 0.45 µm Processed @ Ambient Temperature

The MPVP (Membrane Patch Varnish Potential) part of this analysis checks for damage to the fluid being analysed, this analysis uses a 50X larger volume of sample and filters down to a 1/6th of the size of the filter used for the WDA analysis.

The Membrane Patch Filter was gravimetrically analyzed and weighed. Next the patch was inspected and analysed upon the Membrane Patch Varnish Potential

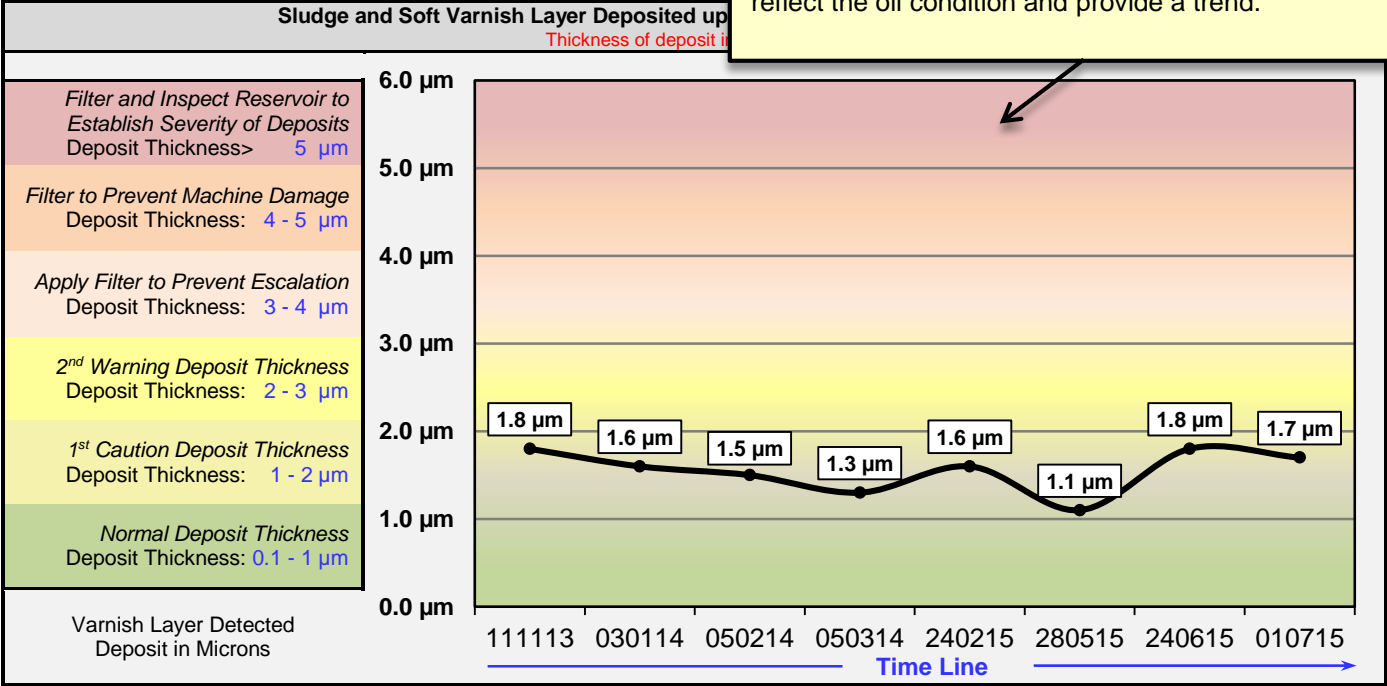
Sludge and Soft Varnish layer detected Chart:
 We are able to measure the amount of varnish deposited upon the varnish potential patch. This can reflect the oil condition and provide a trend.

The Turbine 1 Oil Sample Membrane Patch Filter analysis indicates the system is slowly cleaning it's self with the smooth layer of damaged lubricant deposited reducing back to 1.1 μm of layered gelled lubricant.

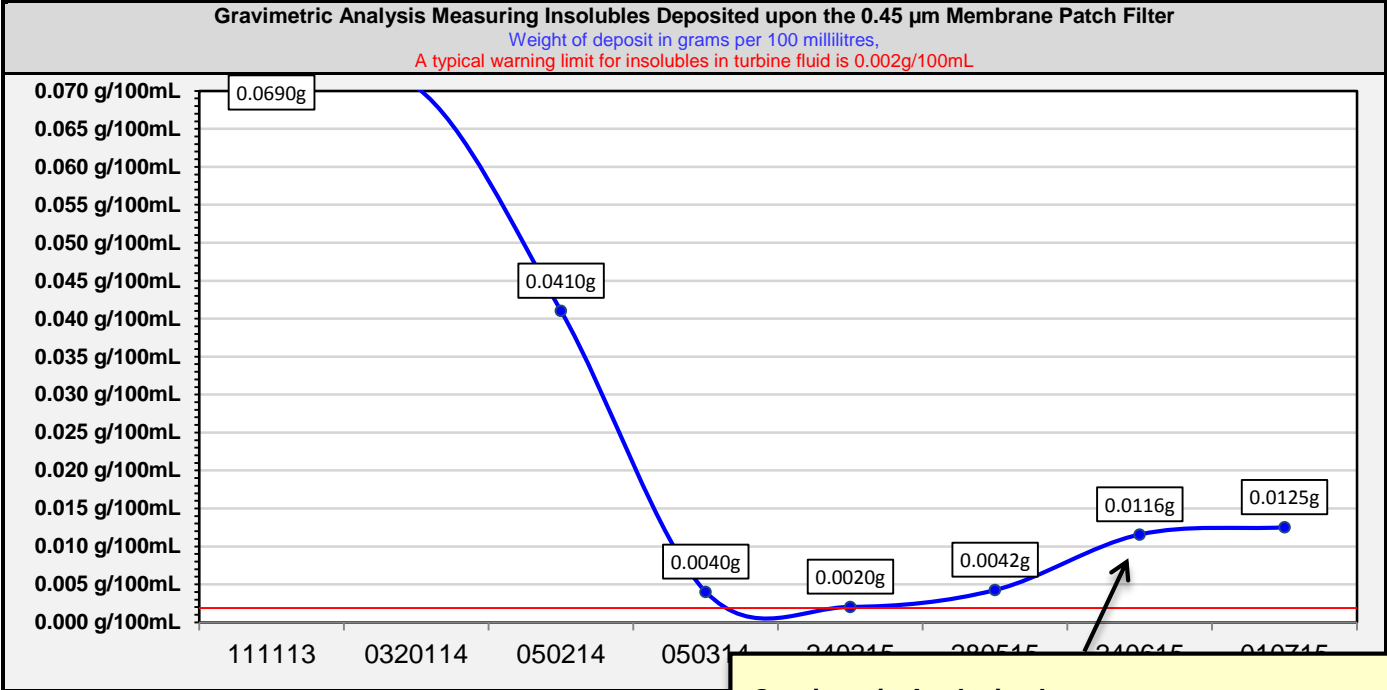
Gravimetric Analysis chart:
 Weighing the deposition of varnish and other wear upon the filter helps us trend the condition of the item.

The metallic wear debris and resolubilised globules of gelled lubricant deposited increased the gravimetric analysis insoluble weight with 0.00424 g of insoluble debris per 100 mL of turbine fluid sample deposited upon the Membrane Patch Filter.
